STEFAN FÜGLISTER

CONGRESS, 14 - 17 SEPTEMBER 2017, UNIVERSITY OF BASEL

Kyshtym accident I

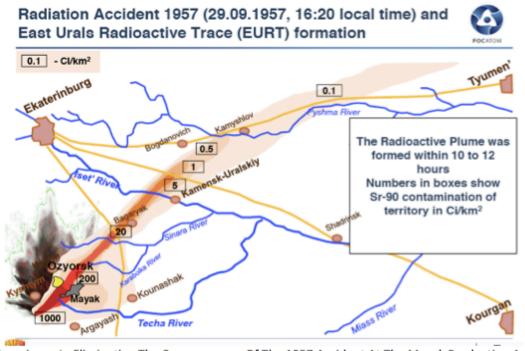
The official data from the Russian source

Quelle: Experience In Eliminating The Consequences Of The 1957 Accident At The Mayak Production Association

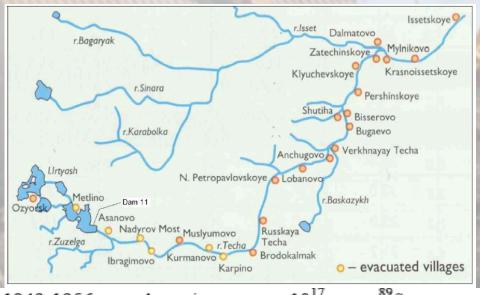
Discharges into Techa river, flood in 1951

89Sr 10¹⁷ Techa River 8 (1-12) 1949-1956 Aquatic $^{90}Sr + ^{90}Y$ 21 (8-42) ¹³⁷Cs 11 (8-18) $^{95}Zr + ^{95}Nb$ 12 (8-24) 103 Ru + 106 Ru 24 (12-51) U + PuOthers a 22 (13-27)

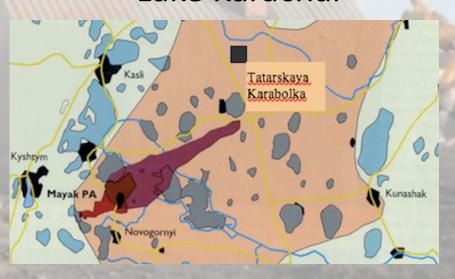
So called Wind resuspension from the banks of Lake Karachai

Wind resuspension	1967	Aerial	2.2×10^{13}	90 Sr + 90 Y	34
from the banks of				¹³⁷ Cs	48
Lake Karachai				¹⁴⁴ Ce + ¹⁴⁴ Pr	18
